# Test Report

No.: 64.190.25.3931.01-00

1	Product Description	Tripod
2	Dimensions / Weight	606×304×105mm/10kg

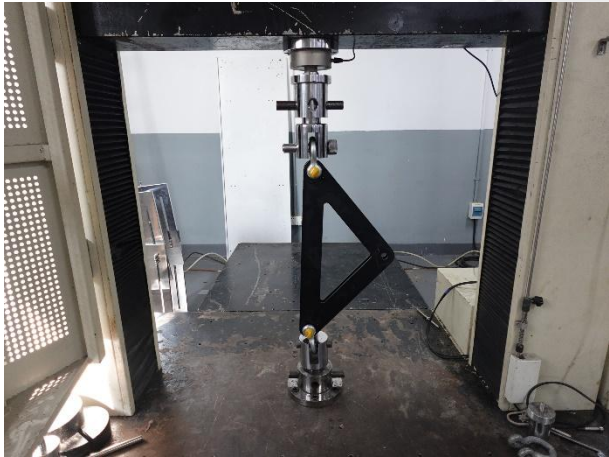
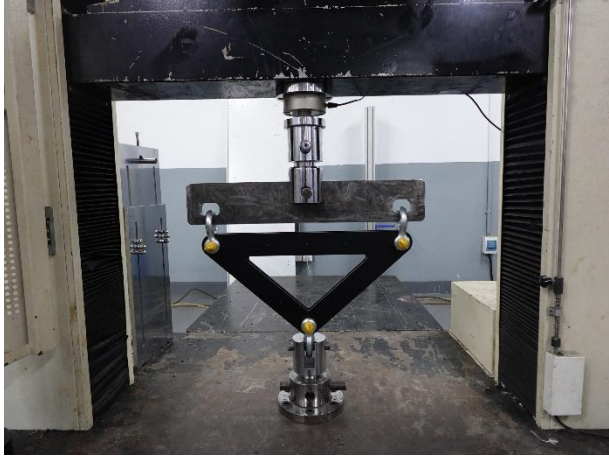
During test	Testing curve

Item	Requirement-Test	Measuring result-Remark
1	<b>Tension test</b> Apply suitable clamps firmly fix the product to the test machine. Start the test machine with the rate of 100 mm per minute; Until the force reaches 131000 N, then remove the tension. Observe and record any breakage, component fracture after test.	No damage or component fracture was found after the tension test in two states.

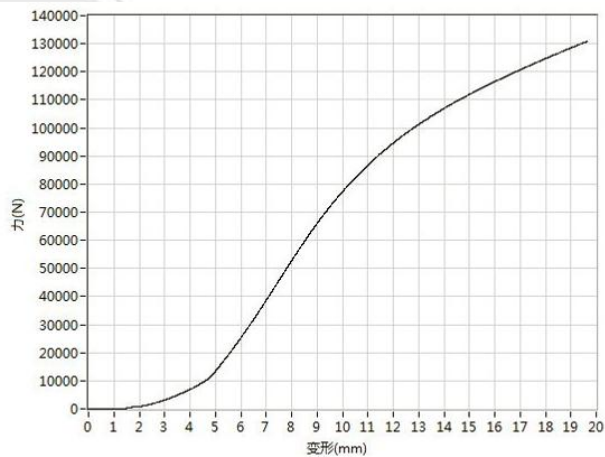
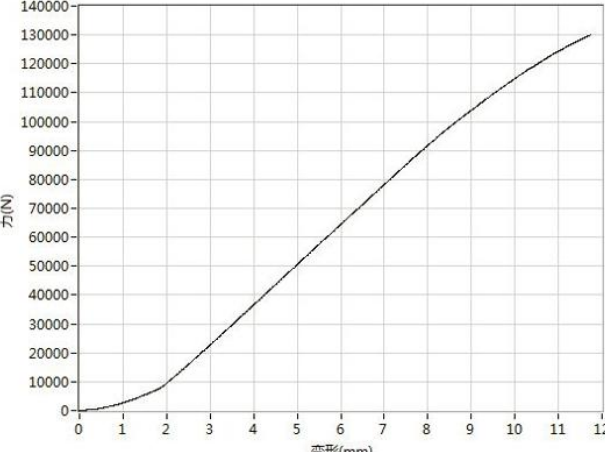
1. The test results exclusively based on the submitted sample.
2. Tripod load capacity is expected to reach 130985N and the actual test force reaches 131000N, so the test force is greater than the expected force.
3. Specific requirement of test report as per clause 7.8.3 of CNAS-CL01-2018 or other accreditation scheme, such as: remark of subcontract information or on-site testing information.
